Underground Drainage Vault Repair, RJS

Bid #18-10

## **ADDENDUM ONE to Bid #18-10**

REF: Vault Inspection

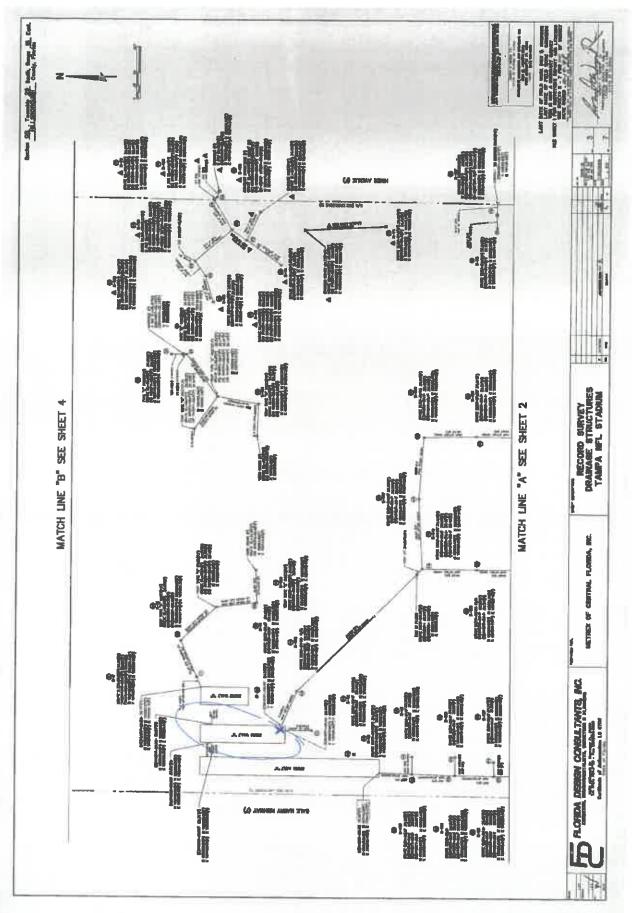
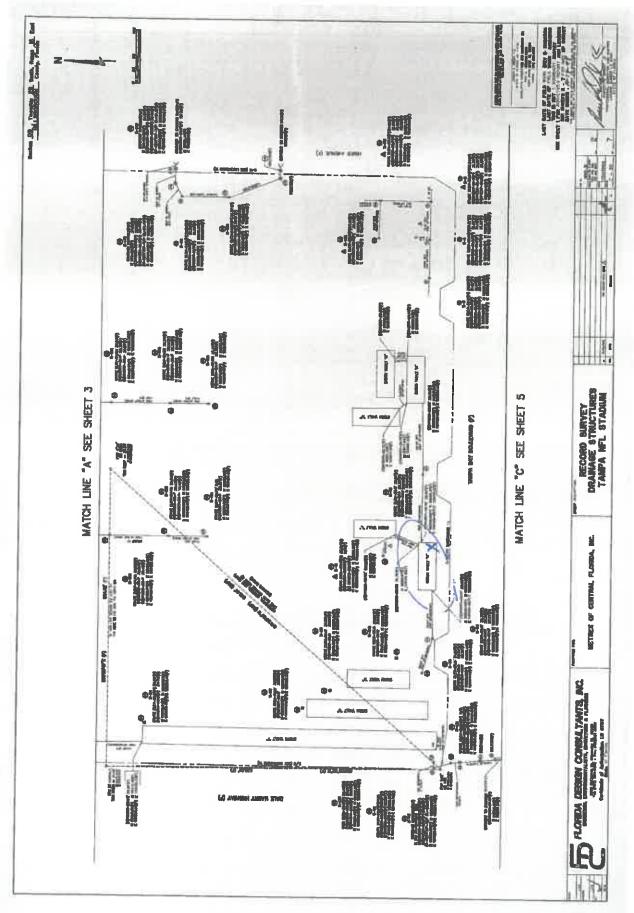
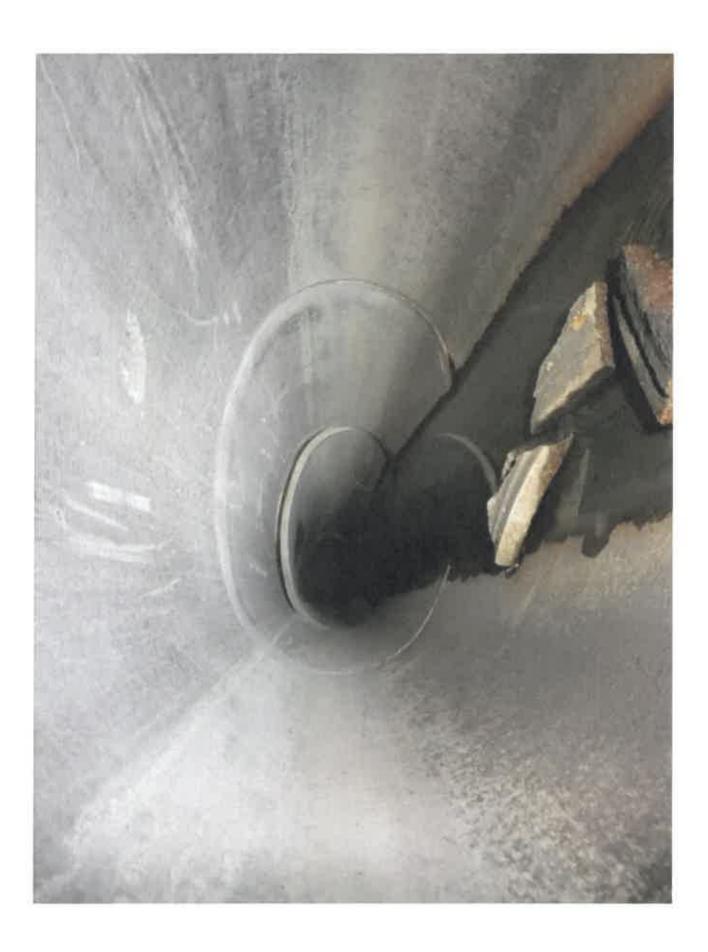
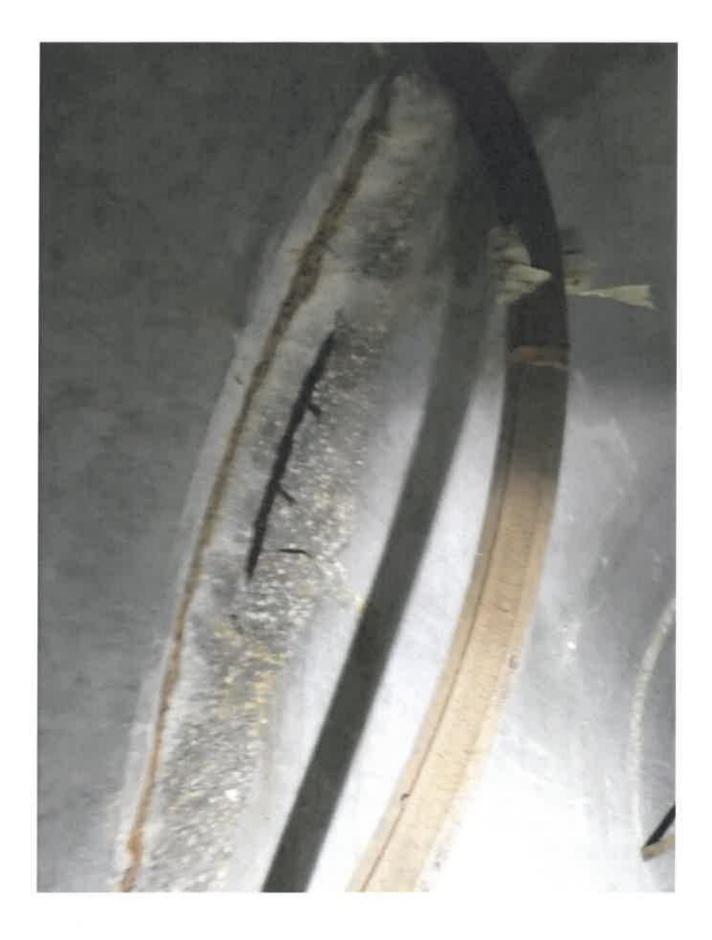
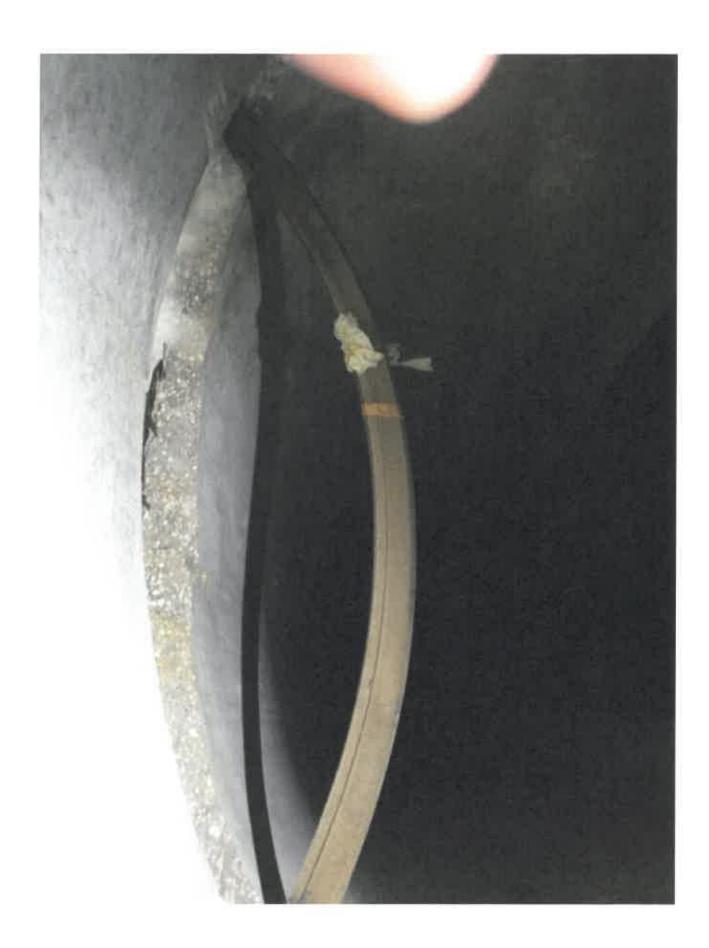
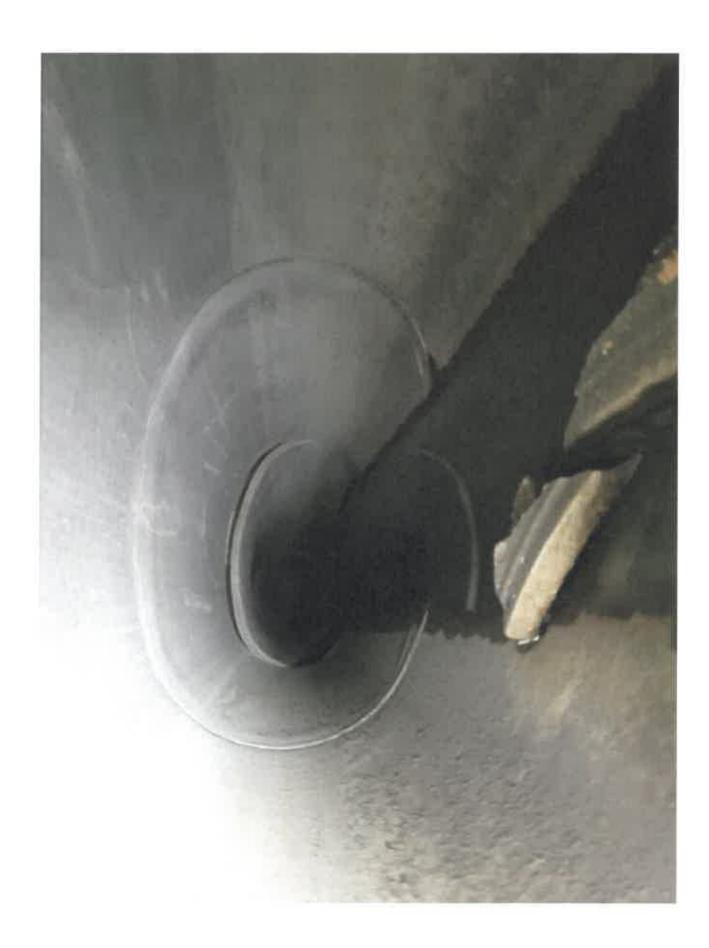
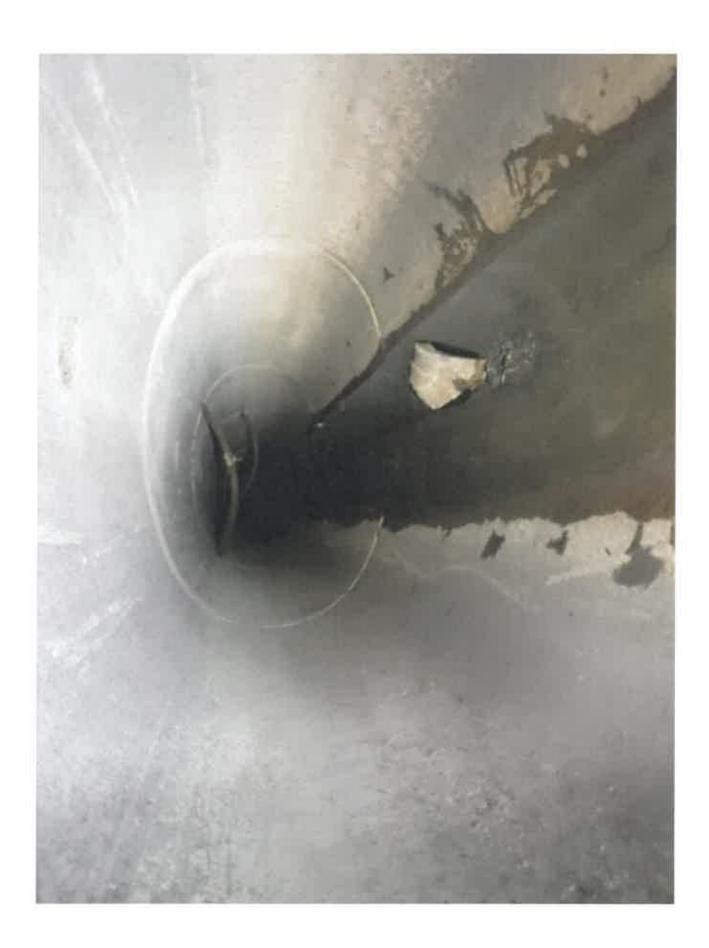
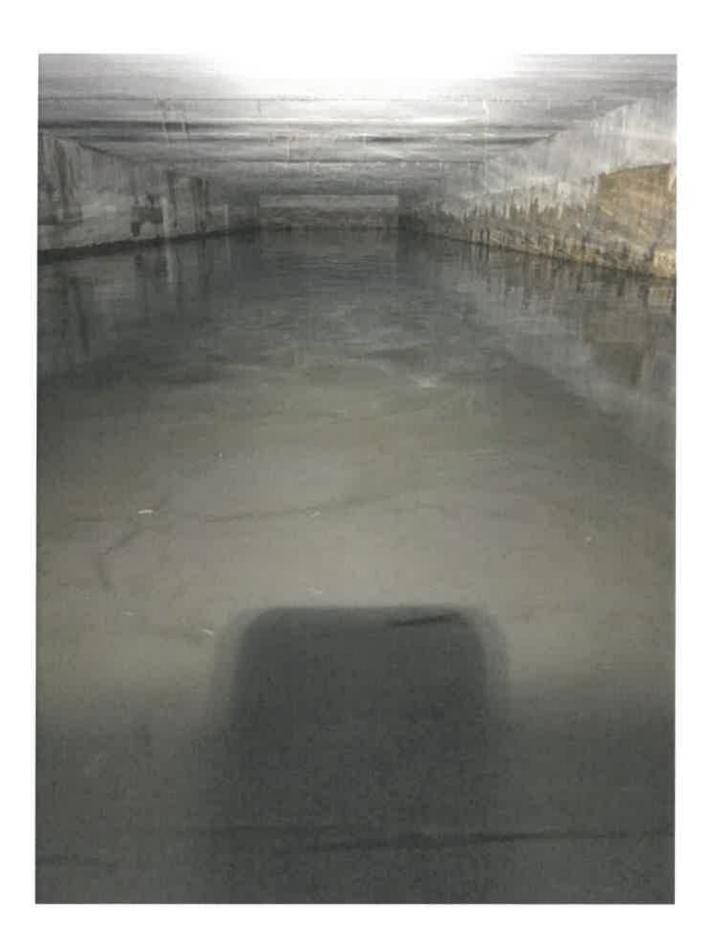
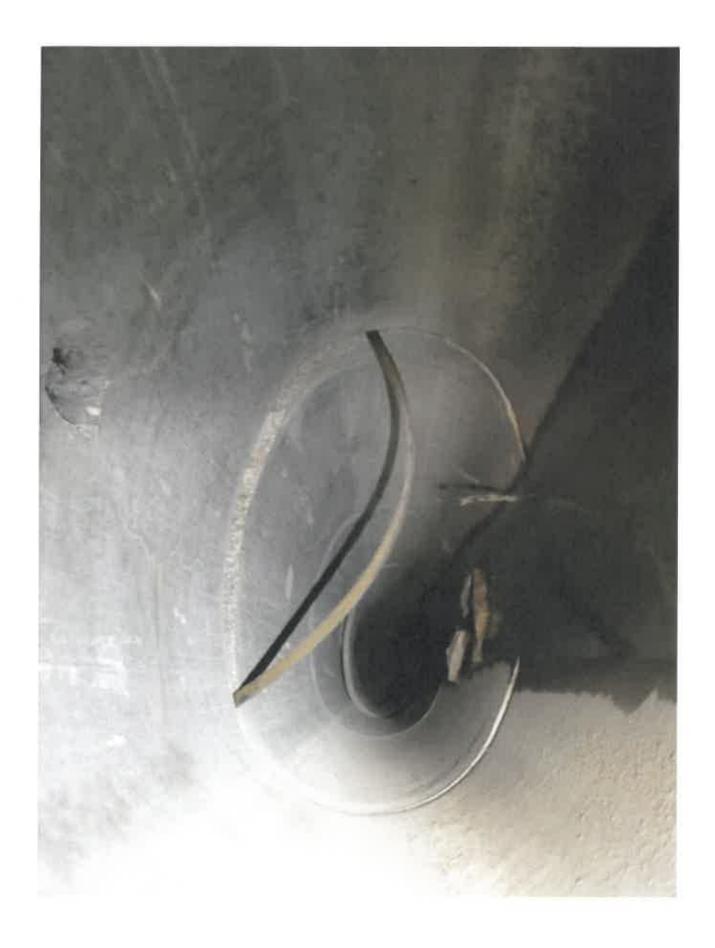
Our inspection of the vault system conducted on April 18, 2017 showed us two areas that need attention. Vault B (R.A.M. #2) has failing 38"x60" RCP storm pipes on the southeast corner. Videos 4586,4587 and 4588 show some of the problems. We did not continue up the line, but believe further exploration would reveal more of the same. Vault K (R.A.M. #7) has a failing wall. Pictures 4601,4602 and 4603 show the failing wall.
